QUATTRA 50 UV LAMP, QUARTZ SLEEVE REPLACEMENT & RE-ASSEMBLY PROCEDURES

QUATTRA UV LAMP REPLACEMENT PROCEDURE

QUATTRA QUARTZ SLEEVE REPLACEMENT

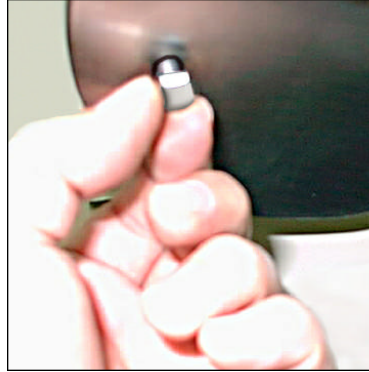
Figure 1

1. Shut down all power to the system and close manual shut-off valves.
2. Remove drain plug from bottom of unit to drain chamber if required (Figure 1), replace plug when finished.

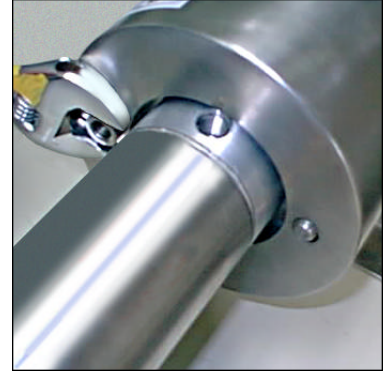
Figure 2

3. Remove the two - 1/2" jam nuts that hold the cover in place (Figure 2).
4. Remove back cover (end cap) where wires run into the unit. First loosen strain relief nuts around wires, so that the cables will slide through (Figure 3).

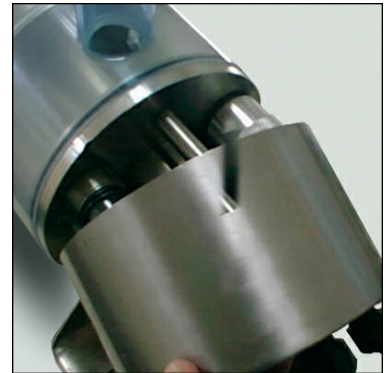
Figure 4

5. Slide back cover making sure the wires in strain relief stay hooked up to lamps (figure 4).
6. Move cover back at least one foot for easy access.
7. Hold end of lamp, remove pin plugs (Figures 5). Note: #207 O-Rings on part of lamp are to keep it centered in quartz sleeve (new lamps are equipped with new O-rings).

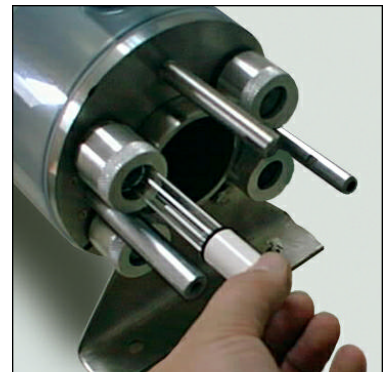
Figure 6

8. Remove lamp from unit. Twist lamp if you feel a snag taking lamp straight out (very fragile),use two hands and hold other end of lamp as it comes out (Figures 6).

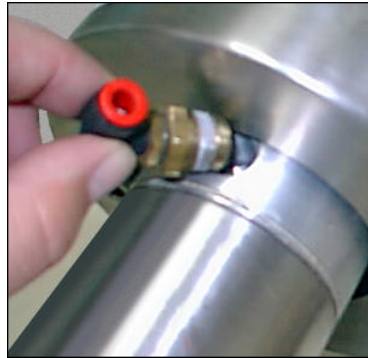
Figure 1

2. Remove fitting on top of the cylinder closest to the cover at air cylinder end (on-site air-figure 1).
3. Remove the two-1/2" jam nuts that hold the cover in place (figure 2).

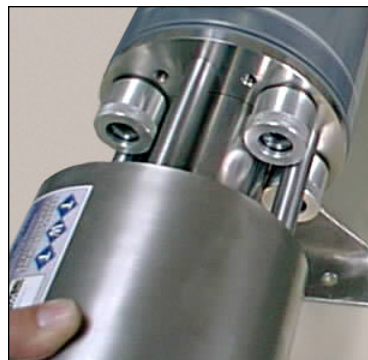
Figure 3

4. Slide cover off (figure 3).
5. Remove all 4 aluminum compression nuts with bumper #211 O-ring in them. Note, if nuts are tight, gently use hand tool to loosen (figure 4).

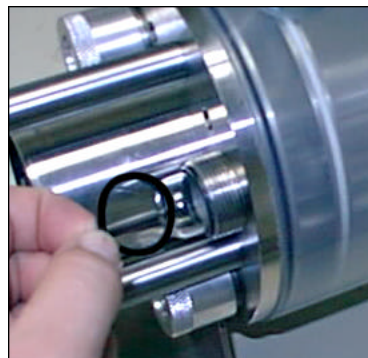
Figure 5

6. You will notice #211 O-rings on all four sleeves. Remove them from both ends of the sleeve (figure 5) and push bottom of sleeve in (at air cylinder end) pulling out sleeve at other end.

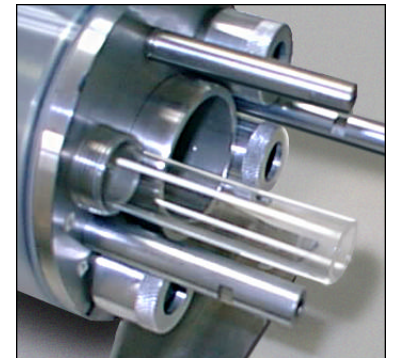
Figure 6

8. Be careful, gently pulling the sleeve out, so that it will not hit the center shaft (figure 6) Two hands should be used, with one hand on the end plate where the sleeve comes out to support it, so as not to hit any metal. Do it the same as when replacing new lamps, using a clean cloth to guide the sleeve in, not touching it with your hands. Always remember after cleaning sleeves & lamps with alcohol and peroxide, **Do not** touch glass with bare hands (hand tighten only).

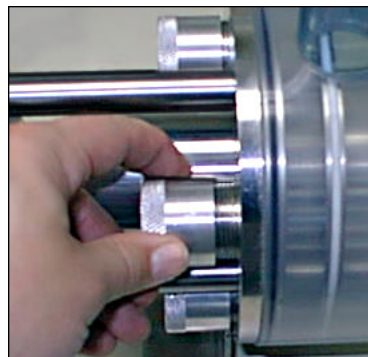
Figure 7

10. Insert the replacement lamps into the quartz sleeve. Gently push the lamp connector against the pins at the end of the lamp.
11. Replace all four aluminum compression nuts (figure 7), hand tighten only (to prevent sleeve breakage).

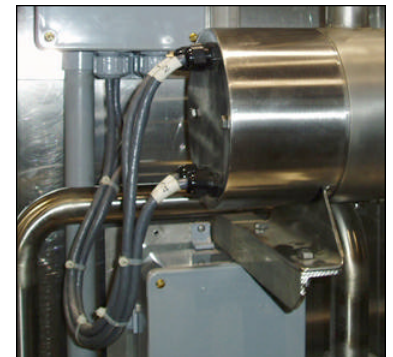
Figure 8

12. Quattra UV unit re-assembled and ready for system operation (figure 8).
13. Turn the fluid supply on slowly and check the unit carefully for leaks. If fluid is leaking from around the rubber seals, tighten the retaining washernuts until the leak stops. A 1/8 turn past this point should be tight enough.
